Manhole Inspection Summary

Manhole # S69Y__013MH

Insp Date: **5/5/08 11:35 AM**

Location Address: **6400 Beckley St.**

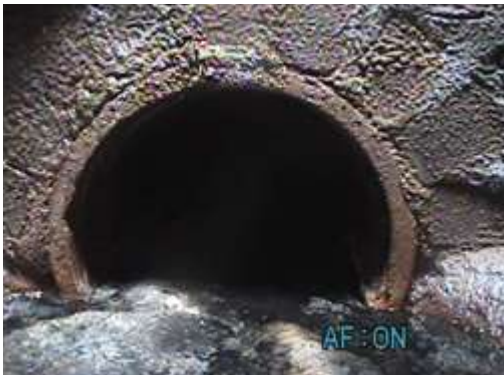
Defect 3

debris @ I7

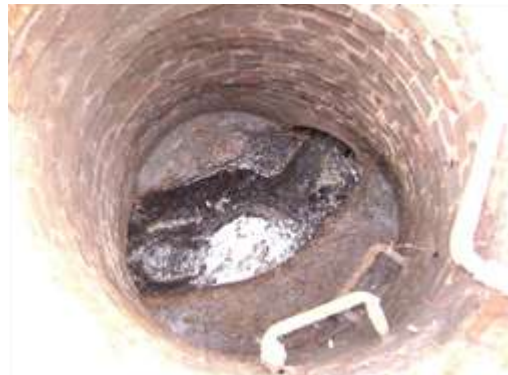
Defect 1

Condition: ☐ Sound ☐ Cracked ☐ Root Intrusion ☐ Deteriorated ☐ Leaks ☒ **Debris**

debris in channel

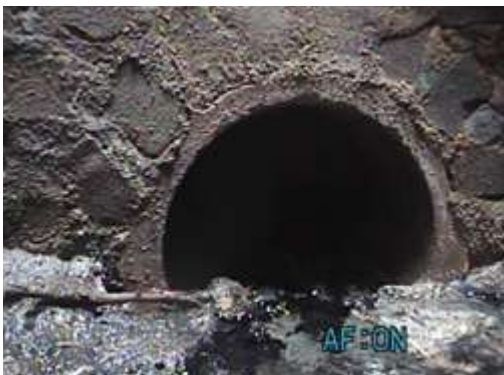
Defect 2

debris @ O12

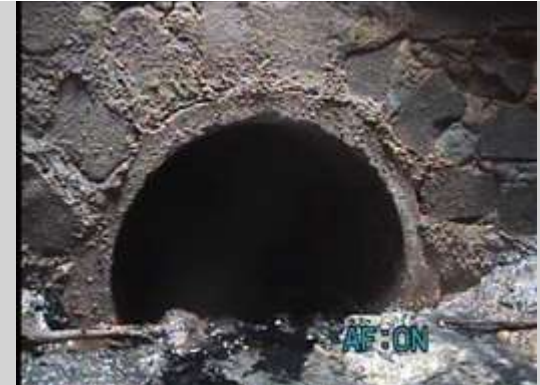
12 O'Clock Outflow

Pipe Height: **12** (in.) Rod and Bar (Angled)
Pipe Material: **Clay** ☐ Pipe Lined
Invert Depth: **8.33** (ft.) Flow Characteristics: **Slow**
Deposits: ☐ None ☐ Mud ☒ **Gravy** ☒ **Debris** ☐ Grease
Silt Depth: **3** (in.) Deposits Extent: **Medium**
Infiltration: **None** Pipe Seal Cond: **Sound**

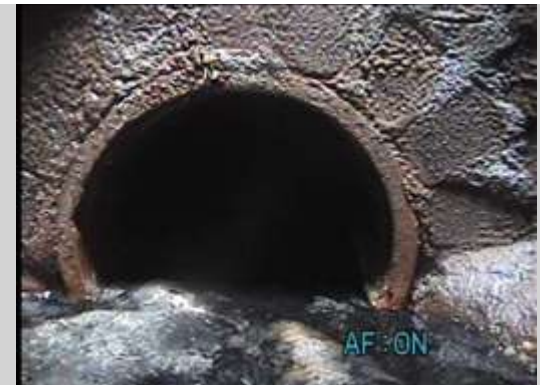
7 O'Clock Inflow

Pipe Height: **12** (in.) Rod and Bar (Angled)
Pipe Material: **Clay** ☐ Pipe Lined
Invert Depth: **8.33** (ft.) Flow Characteristics: **Slow**
Deposits: ☐ None ☐ Mud ☒ **Gravy** ☒ **Debris** ☐ Grease
Silt Depth: **3** (in.) Deposits Extent: **Medium**
Infiltration: **None** Pipe Seal Cond: **Sound**
